The Klipspruit basin sewer upgrades within the city of Johannesburg – an application of trenchless technologies

by Bharat Gulab, of Johannesburg Water (Pty) Ltd; Cedric Bessit and Meghan Brinkley, both of Vela VKE Consulting Engineers (Pty) Ltd

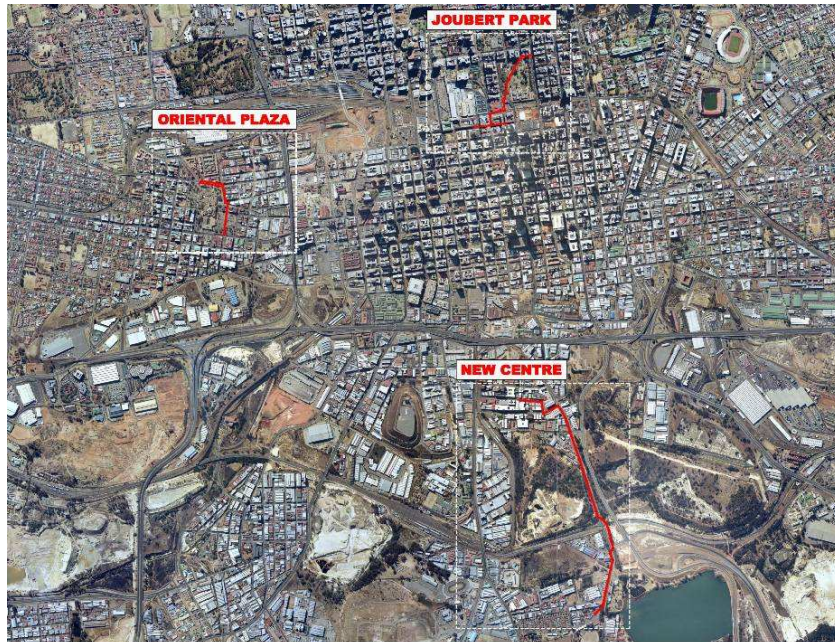
Fig 1: Location of the works

The Klipspruit Sewer Drainage Basin stretches from Braamfontein in the north to Devland in the south, with a total length of sewers of 560 km.

The works were implemented in three locations within the basin as presented in fig 1 on the next page.

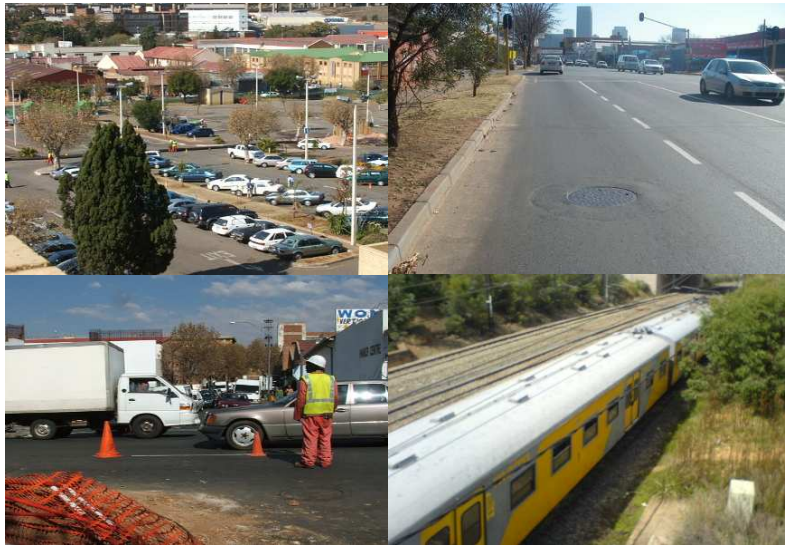
Fig 2a: Oriental Plaza

- at the Oriental Plaza, the upgraded sewers were located within the plaza parking area and the surrounding streets. As the plaza receives approximately 28 000 visitors per day, minimal disruption was crucial
- in Rosettenville, the rehabilitated sewer was located in a major arterial road and crossed underneath a railway line. Hence limited disruption was required.

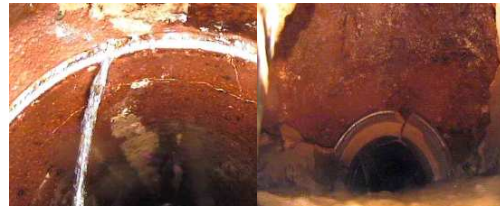
Fig. 3a: Water Infiltration

Fig. 3b: Broken Pipe

The pre-implementation CCTV camera surveys assisted to identify the following general problems:

- corroded pipes
- water infiltration
- cracked pipes
- broken pipes, and
- root intrusion.

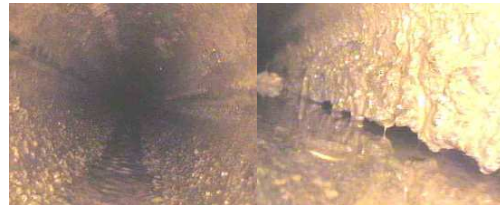
Fig. 3c: Corroded Pipe

Fig. 3d: Corroded Pipe

The survey revealed that the greatest part of the existing sewer had water infiltration, major cracks and major corrosion of the concrete sections. 90 % of the sewer was rehabilitated by means of pipe bursting.

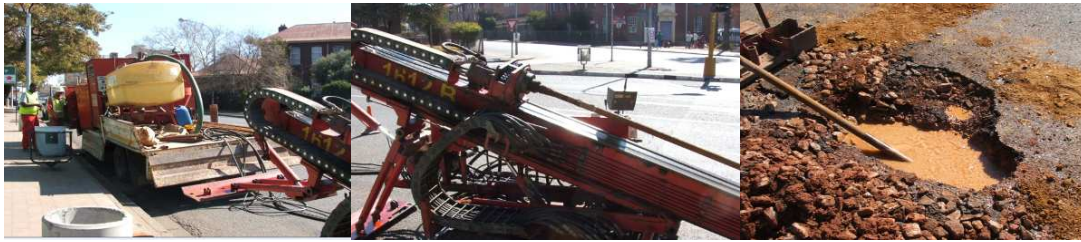
Fig 4a: Horizontal drilling equipment (Oriental Plaza)

The locality of the sewer, 500 mm below the existing stormwater conduit, negated the potential of increasing the capacity by means of pipe bursting, which would also have eliminated the water infiltration. Thus, a new pipe had to be installed parallel to the existing sewer on the opposite side of the road by means of horizontal directional drilling, whilst the existing sewer was CIPP-lined.

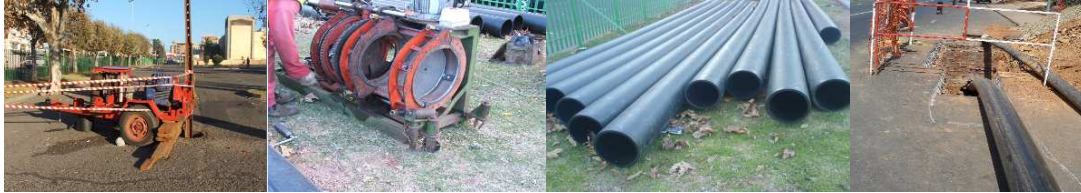
Fig 4b: Pipe Bursting (Oriental Plaza)

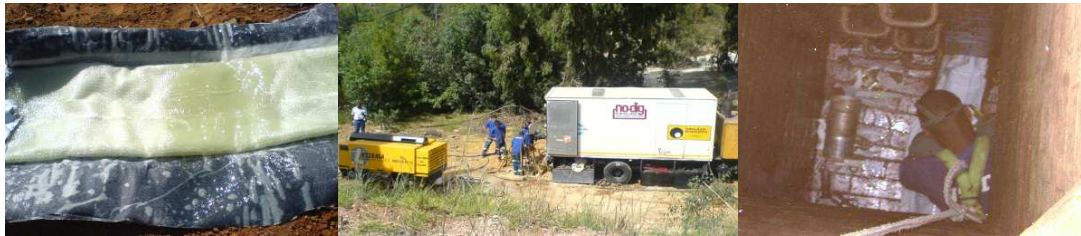
Fig 4c: Cured in place liner (Rosettenville)

The remaining 10 % of the sewer was found to be concrete-encased where it crossed underneath the railway line and a section of the road. This section was rehabilitated by installing a CIPP liner.
